Manhole Inspection Summary

Manhole # S35QQ_012MH

Insp Date: **1/23/07 12:56 PM**

Location Address: **2412 BARCLAY ST**

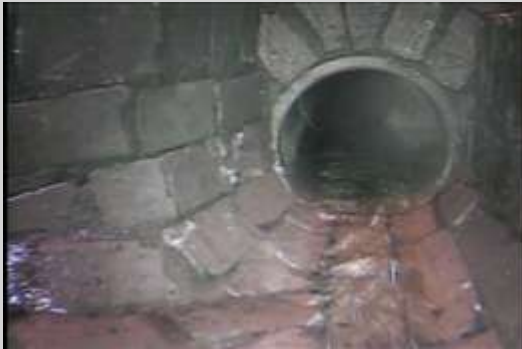
8 in. Circular Gravity Sewer Pipe Out @ 12 O'Clock

Pipe Material: **Clay** ☐ Pipe Lined

Invert Depth: **7.92** (ft.) Flow Characteristics: **Slow**

Infiltration: **None** Pipe Seal Cond: **Unknown**

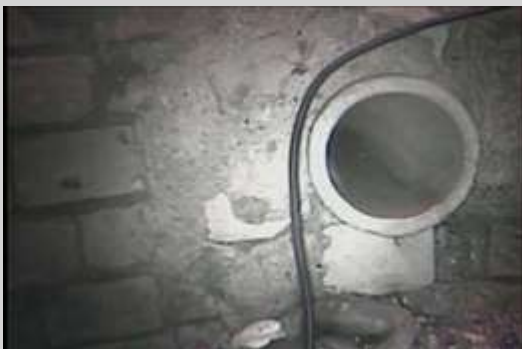
4 in. Circular Gravity Sewer Pipe In @ 5 O'Clock

Pipe Material: **Clay** ☐ Pipe Lined

Invert Depth: **7.55** (ft.) Flow Characteristics: **None**

Infiltration: **None** Pipe Seal Cond: **Unknown**
